State of Nevada
Department of Tourism & Cultural Affairs
Division of Museums & History
Marjorie Russell Clothing & Textile Research Center
Facility Condition Analysis

2351 Arrowhead Drive
Carson City, Nevada 89701

Site Number: 9852
STATE OF NEVADA PUBLIC WORKS DIVISION
FACILITY CONDITION ANALYSIS

Report Printed in August 2013

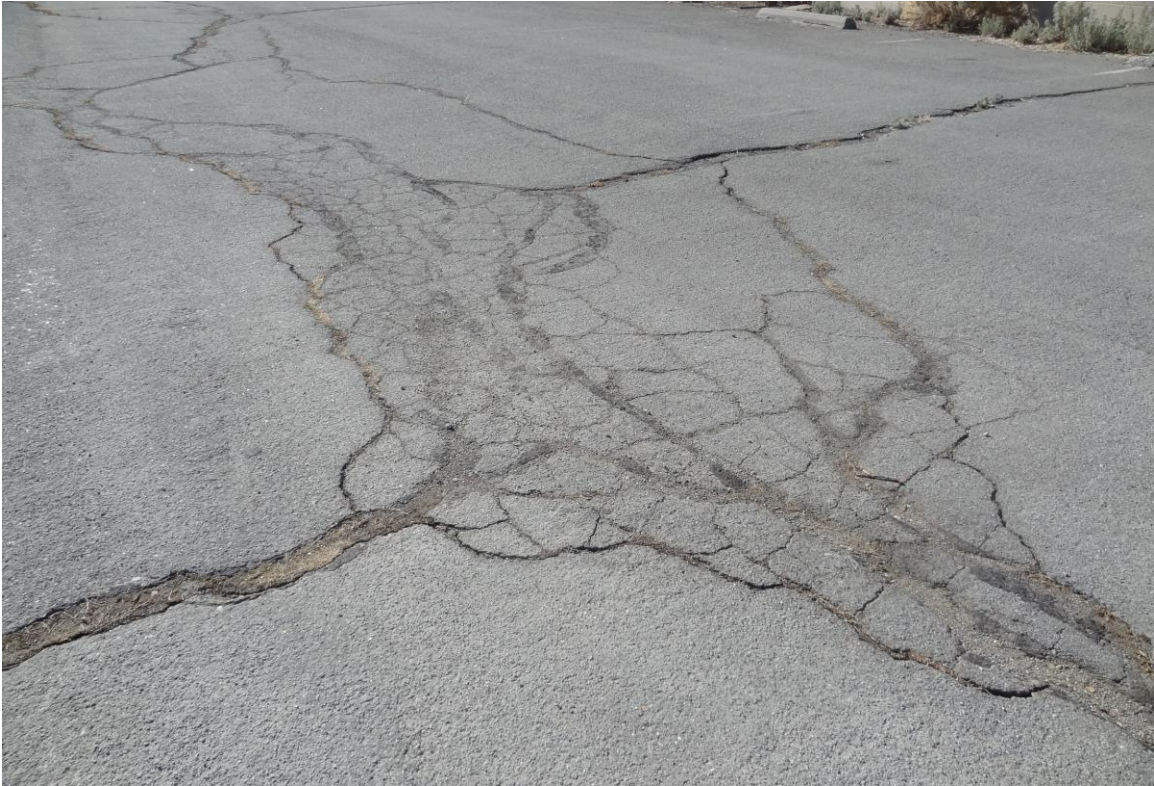
The existing asphalt concrete paving is in poor shape. There are large cracks and areas of alligatoring and is showing signs of failure. This project would provide for the removal and replacement of AC paving and sealing of the entire paved surface. Also included is ADA accessible parking, striping, signage and wheel stops. 30,000 square feet was used to generate this estimate. This project should be implemented within the next two years.

Marjorie Russell Research Center Site – FCA Site #9852
Description: Asphalt paving failure.

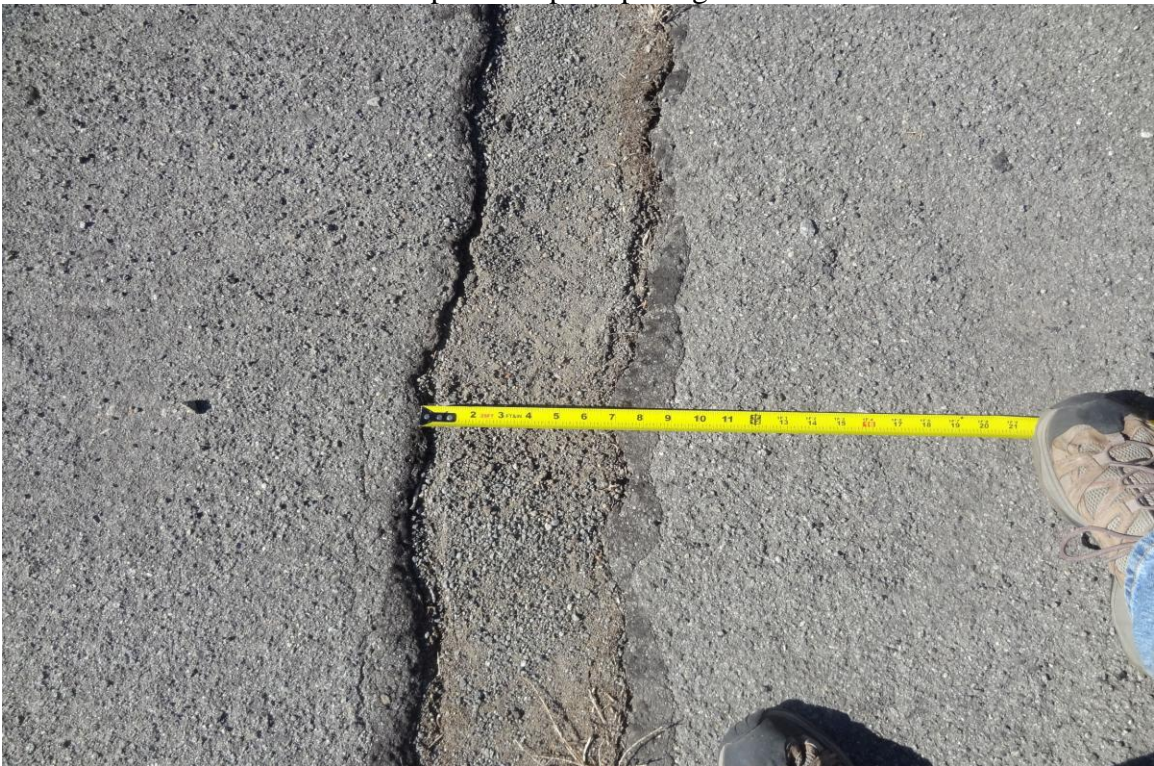
Marjorie Russell Research Center Site – FCA Site #9852
Description: Large (7") crack in need of maintenance.

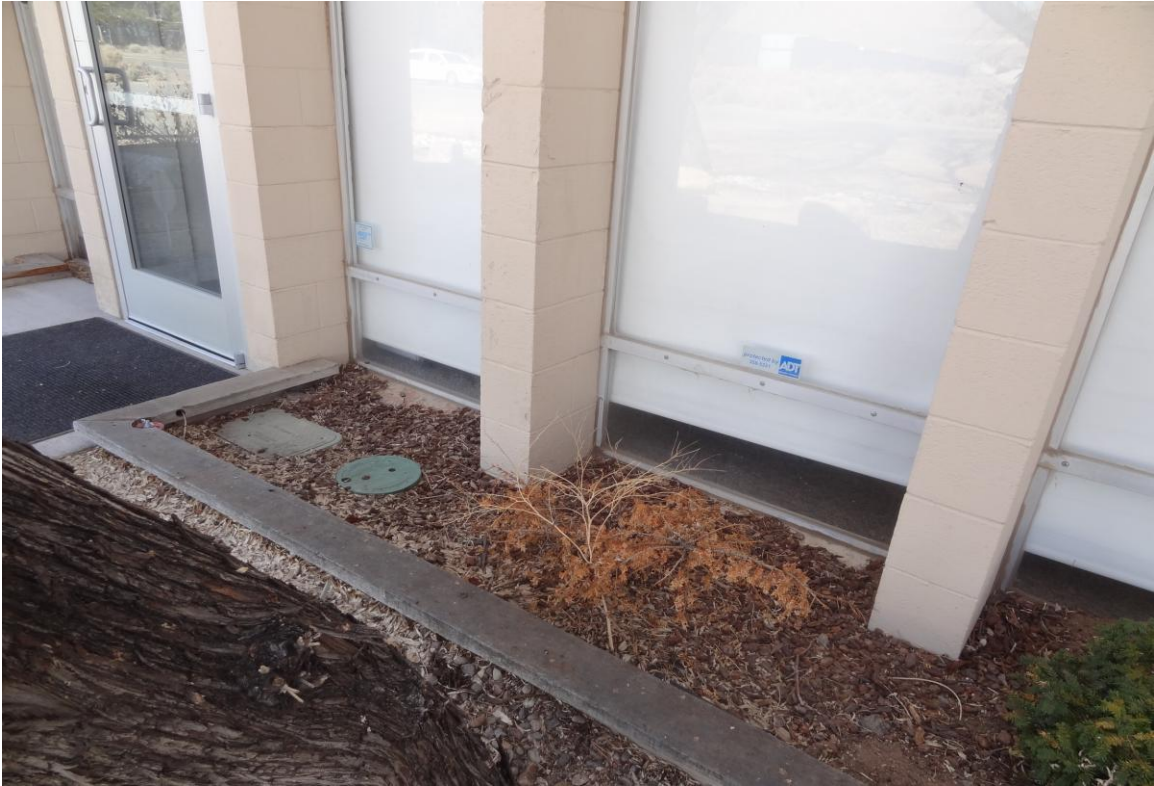
This building has planters across the front of the building that extend up onto the exterior wall. This practice promotes water infiltration through the side of the building and has been known to cause mold growth along the exterior walls of buildings.

Marjorie Russell Research Center Site – FCA Site #9852
Description: Recommend removal of planter.

This project recommends that the planters be removed as soon as feasible and replaced with xeriscaping.

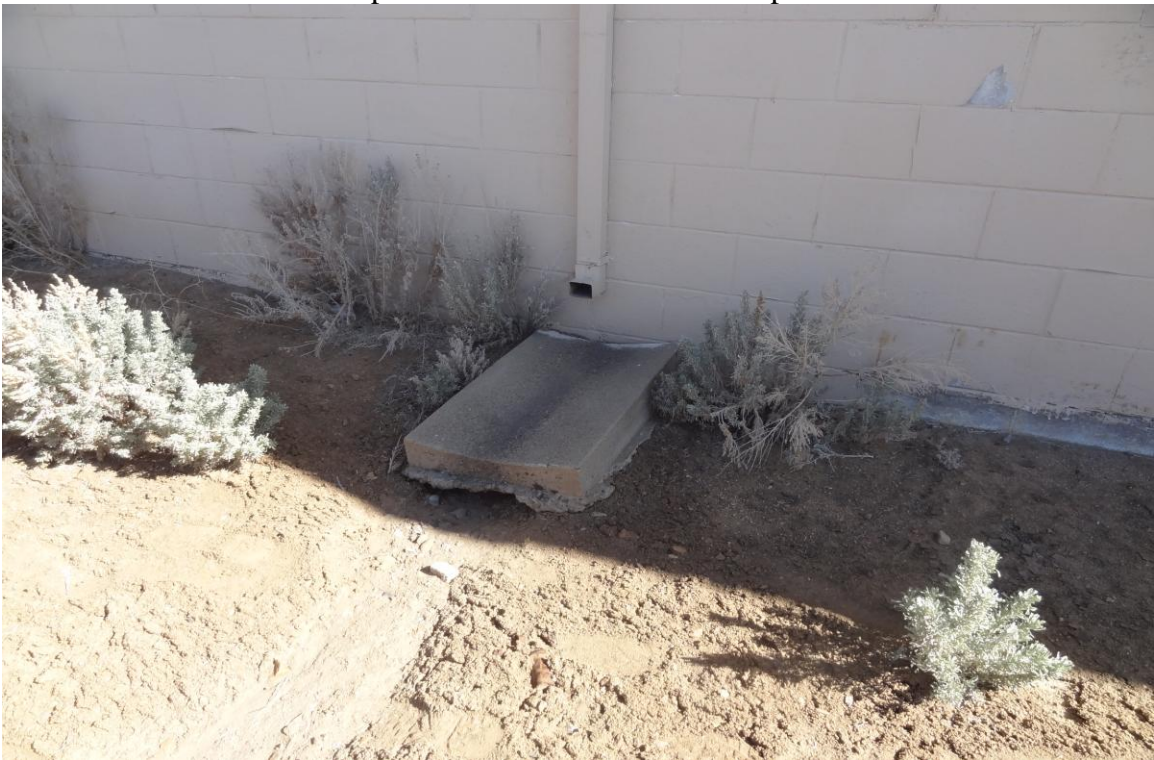
The west side of the building has some areas in need of drainage improvements where the roof drainage down spouts terminate at grade. This project would provide for down spout extensions to a gravel drywell capable of handling runoff from rain and snow melt. This project also addresses the recommended removal of the planter areas on the north side of the facility as the exterior grade is at the same level as the floor and glazing panels.

Marjorie Russell Research Center Site – FCA Site #9852
Description: Downspout discharge in need of erosion improvements.

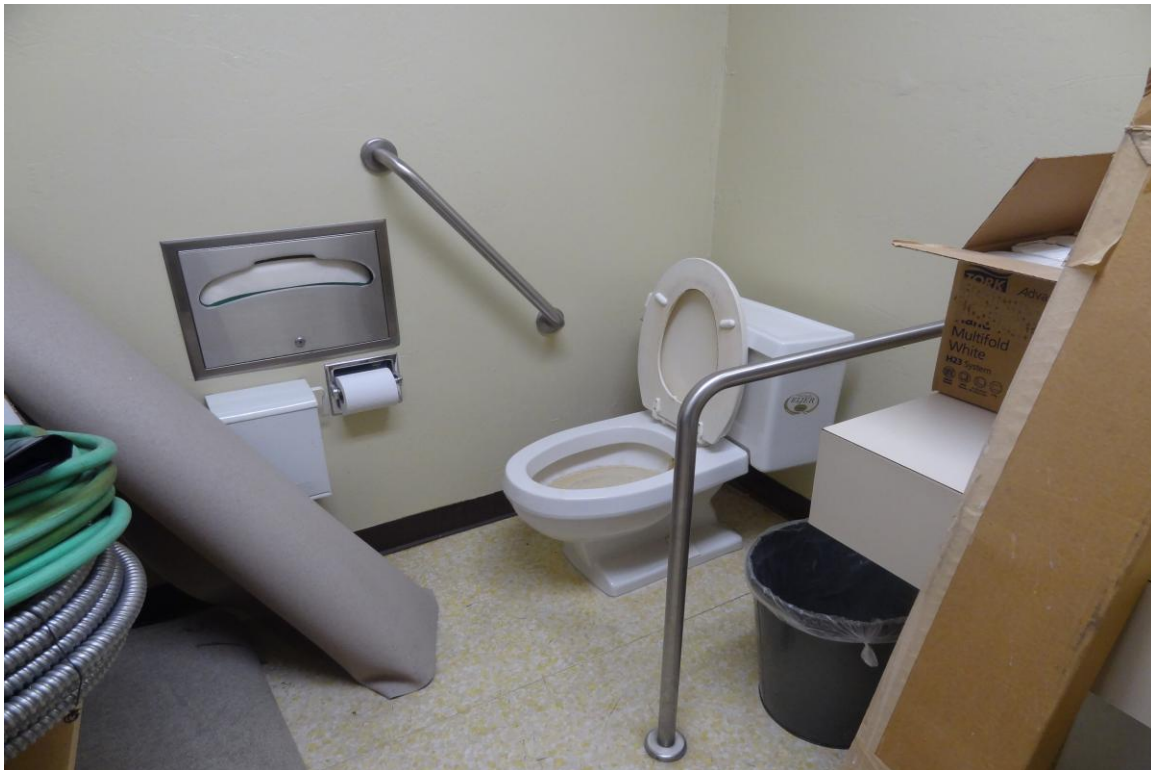
Marjorie Russell Research Center – FCA Building #0208

Description: Restroom in need of a remodel.

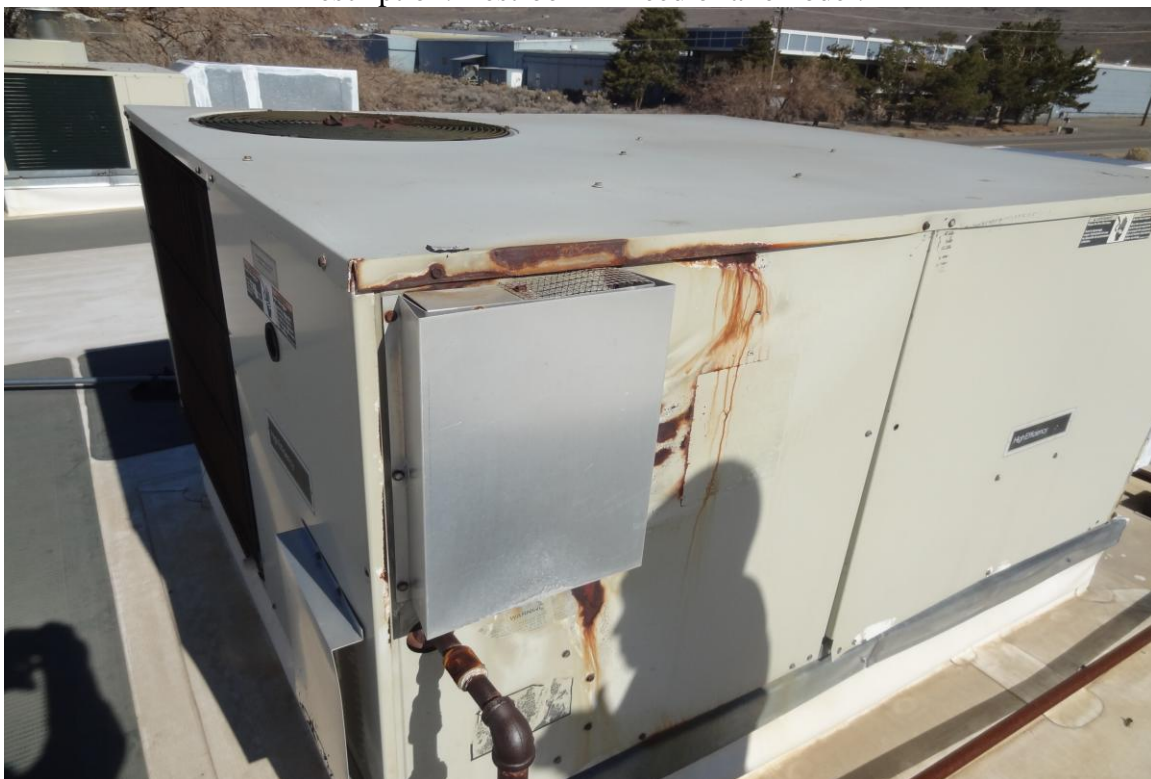
Marjorie Russell Research Center – FCA Building #0208

The three HVAC roof top units are over 20+ years old. They are not energy efficient, need constant repairs and have reached the end of their expected and useful life. This project would provide for installation of three new HVAC packaged units and cleaning of the existing duct work. This project includes removal and disposal of the existing HVAC units and all required connections to utilities.

Description: Roof mounted HVAC unit in need of replacement.

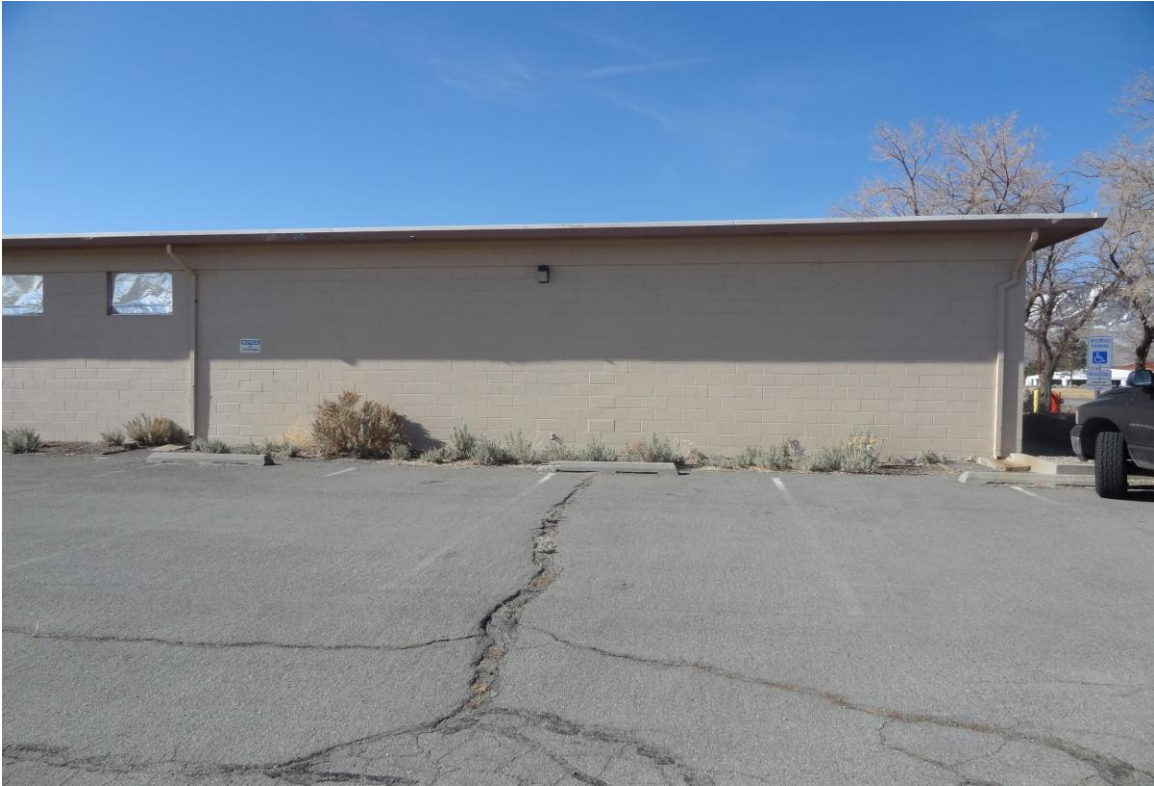
Marjorie Russell Research Center – FCA Building #0208
Description: Exterior of the building, note damaged asphalt paving.
